# Nippon Recycle Center: Detecting Fire Before It Starts

Bi-Spectral Thermal Monitoring for Rechargeable Battery Recycling

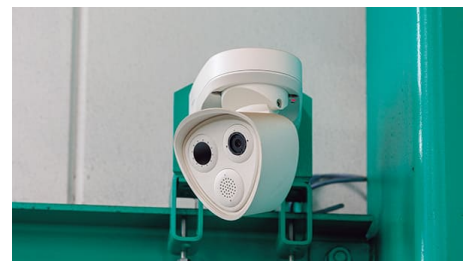
*MOBOTIX M73 thermal camera, installed at the collection & sorting facility*

- **Timeline:** One thermal camera installed April 2024 at the collection and sorting facility; two more added October 2025 on a newly built production line.
- **Support:** Konica Minolta Japan tuned detection zones on site, resolved early false alarms (excluding a sunlit window, taping a reflective crane surface), and produced documentation as needed.
- **Integration:** The production-line cameras connect directly to Nippon Recycle Center's own control software rather than running as a separate monitoring system.

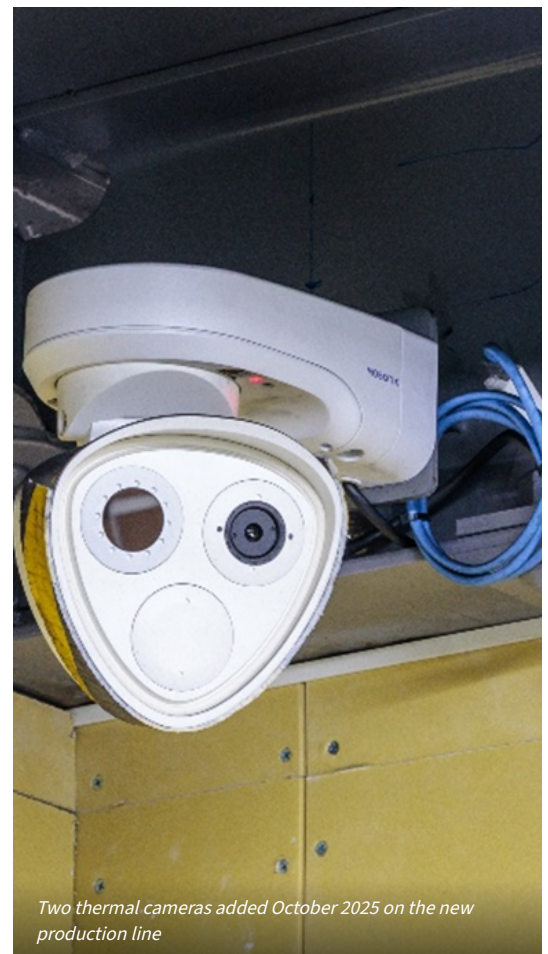
*Two thermal cameras added October 2025 on the new production line*
