Traffic Directorate, Iceland

The Icelandic Road Traffic Directorate

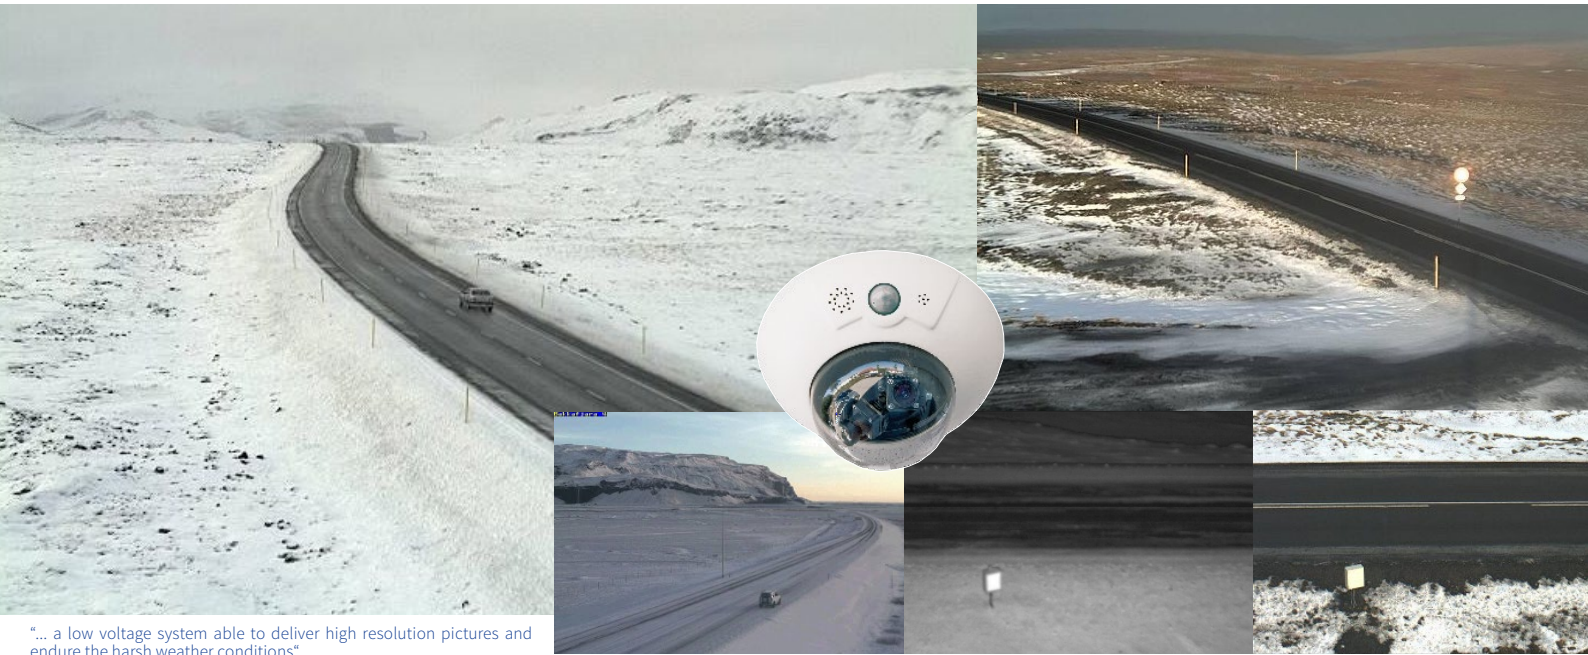
"... a low voltage system able to deliver high resolution pictures and endure the harsh weather conditions"
